PHASE I ENVIRONMENTAL SITE ASSESSMENT

EAST LANDING AREA ST. PAUL ISLAND, ALASKA

August 24, 2004

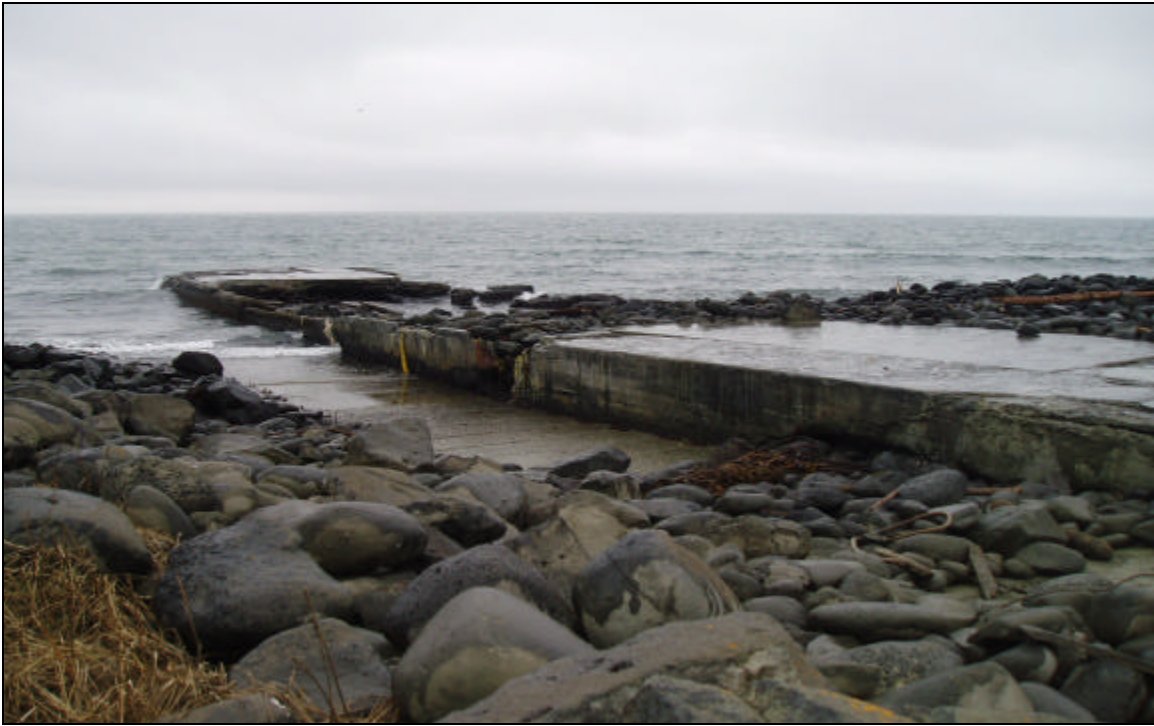
Photograph No. 1

Description: Looking east at the eroding concrete pad associated with the landing dock.

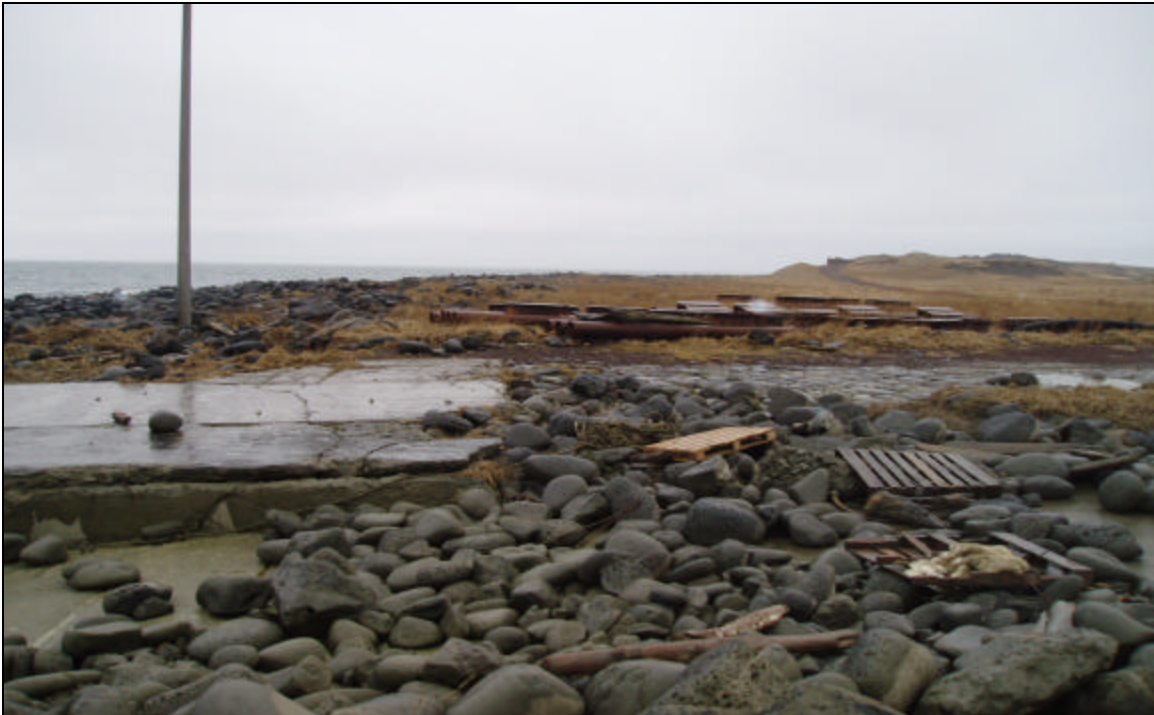
Photograph No. 2

Description: Looking southeast at the property. The abandoned power pole and the rusted metal girders are visible in the distance.

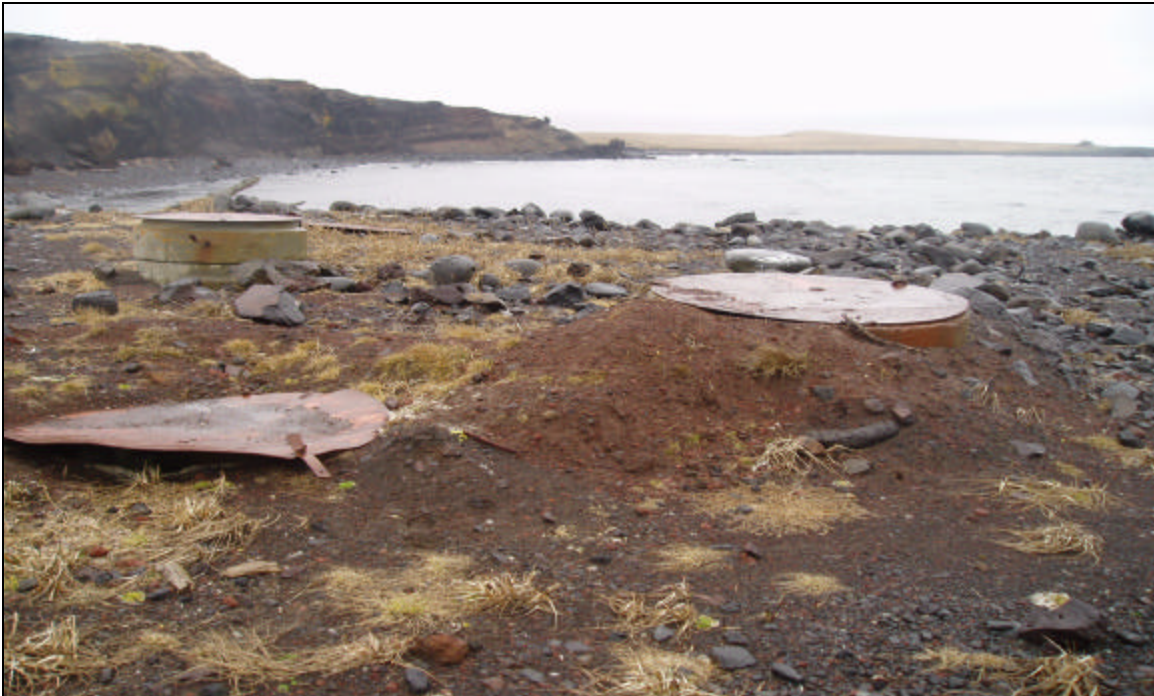
Photograph No. 3
Orientation: Northeast
Description: Looking northeast at the abandoned catch basins.

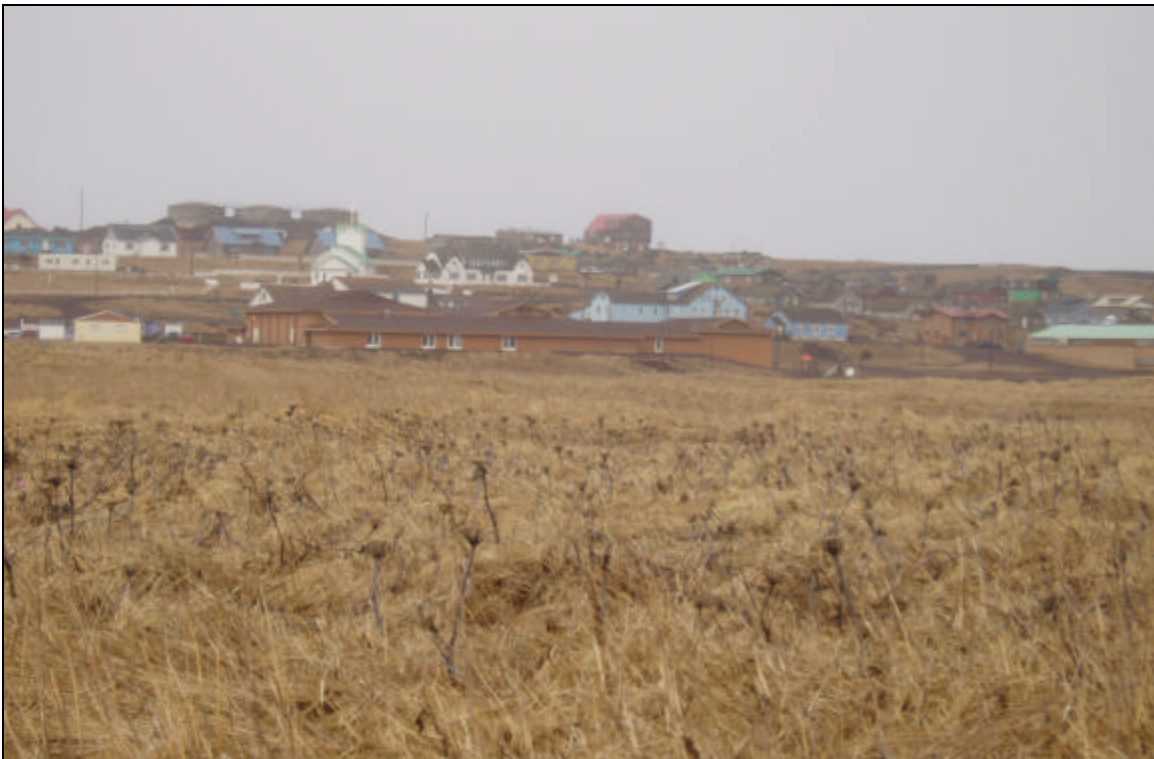
Photograph No. 4
Orientation: West
Description: Looking west from the subject property. The St. Paul School is visible in the distance.

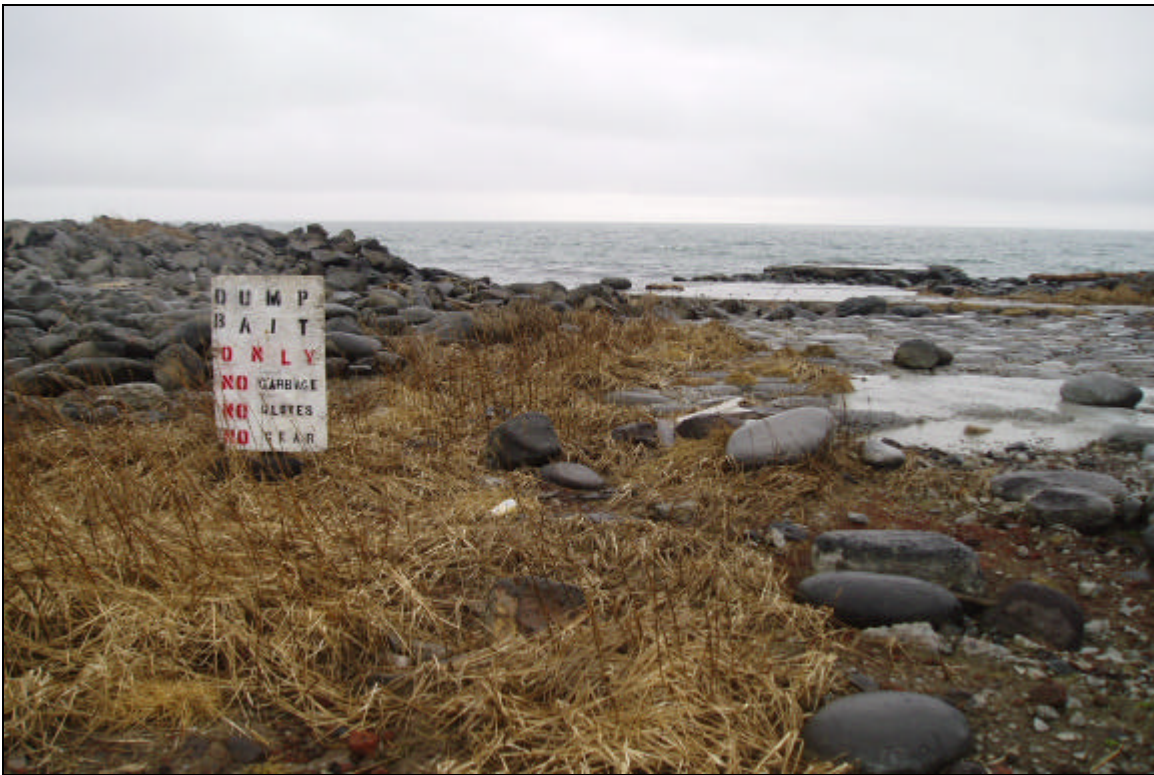
Photograph No. 5

Description: Looking east at the subject property. The sign states "Dump Bait Only – No Garbage – No Gloves – No Gear".

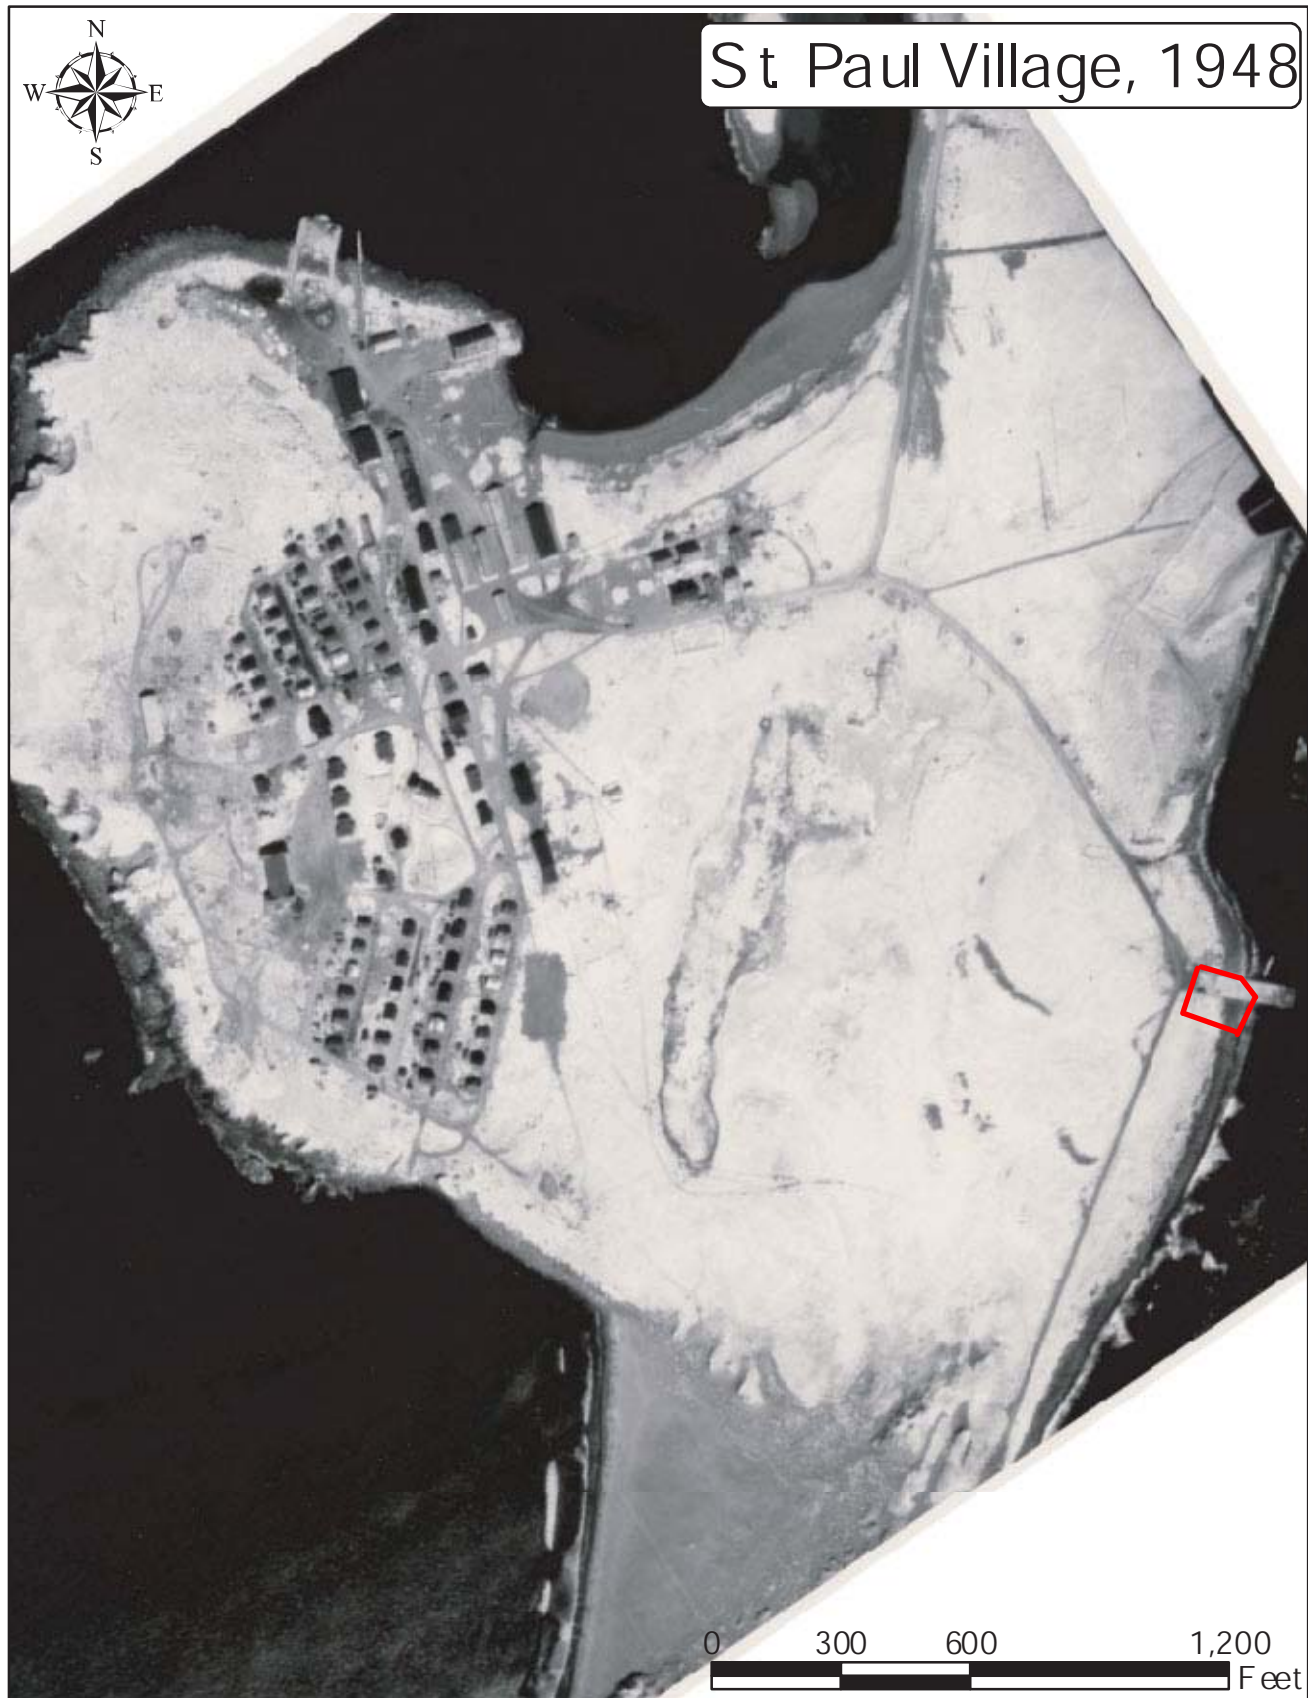
St Paul Village, 1948

-
- **1948.** This photograph shows the concrete pad related to the landing dock. Surrounding sites appear to be undeveloped land to the north, south. East Landing Road exists to the west of the property, followed by what appears to be undeveloped land. The site is located adjacent to the Bering Sea to the east.

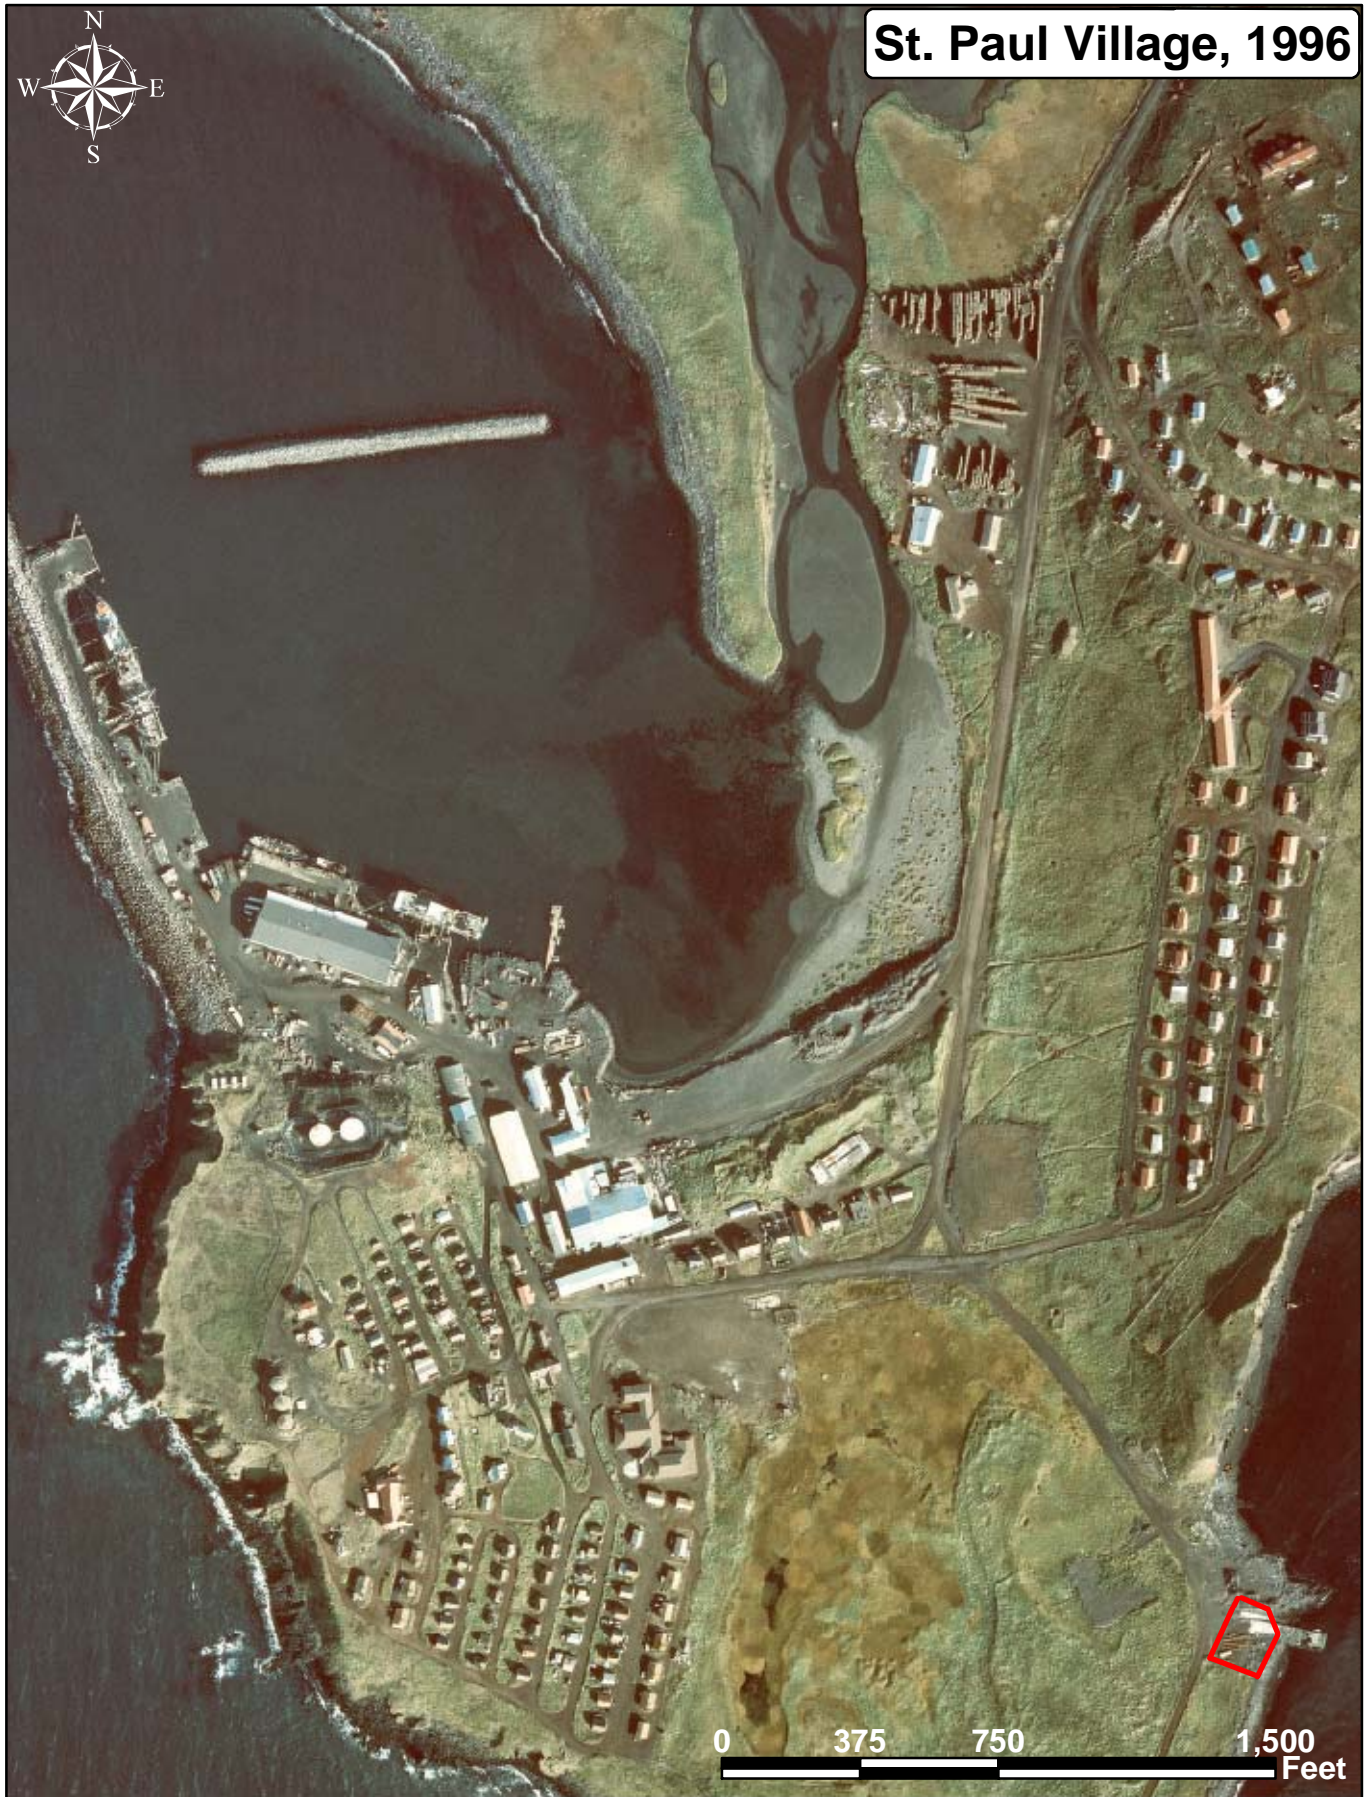
St. Paul Village, 1996

- **1996.** This photograph shows the eroded concrete pad related to the landing dock. The site appears to exist as with current conditions. Surrounding sites appear to be undeveloped land to the north and south. East Landing Road exists to the west of the property, beyond which is undeveloped land. The site is located adjacent to the Bering Sea to the east.
